## The Setenave Dry Docks Rehabilitation

by Ivan Ramalho de Almeida, Thomaz José Ripper Barbosa Cordeiro, and José Paulo Veríssimo Maia Costa

**S**etenave is a general designation for a shipyard built in the early seventies, at the right shore of the Sado River, south of Lisbon, in Portugal. In 1991, an important structural rehabilitation of the reinforced concrete walls of the Setenave dry docks was performed. Repair was required to overcome the problems of generalized reinforcement corrosion, then evidenced by disaggregation of very large areas of the concrete cover (Fig. 1).

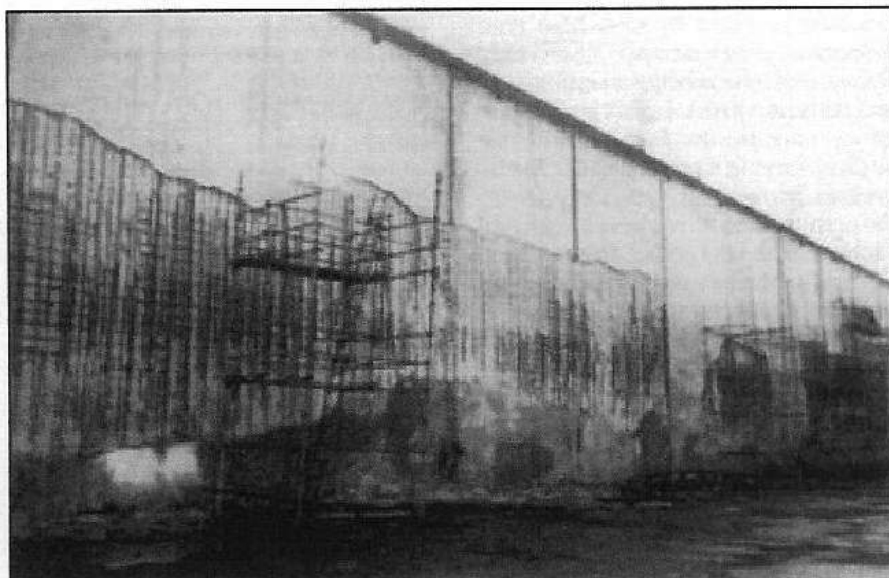
Simple visual observation of walls evidenced the intensity of structural concrete disaggregation (which reached more than 10 m<sup>2</sup> at some places) and the resulting exposure of corroded reinforcement. A preliminary quantification of damaged areas supplied the following data:

Fig. 1: Concrete disaggregation

- The investigation showed the presence of chlorides through diffusion, reaching values at the reinforcement level up to 0.3 percent of concrete mass.

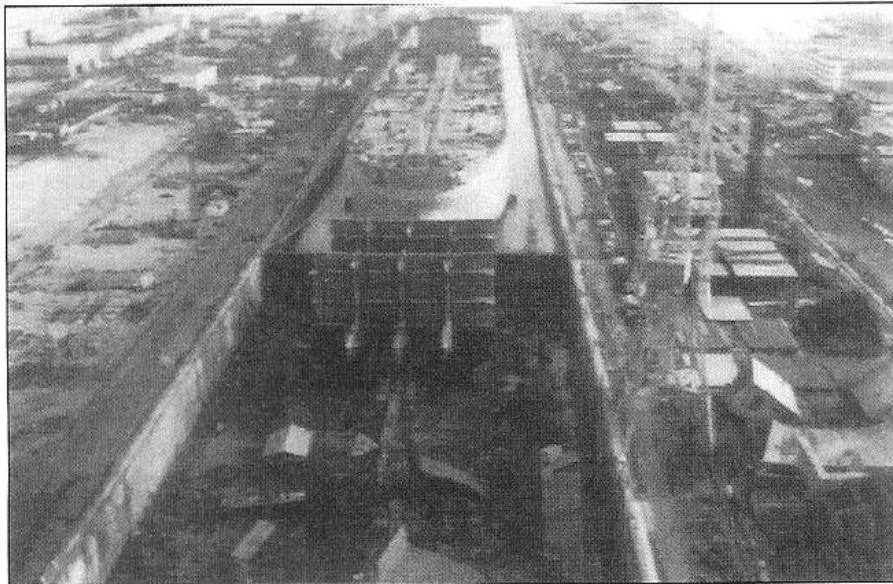
Fig. 5: The docks, again in operation, after the rehabilitation

- Encouraging results were always obtained, largely exceeding the requirements.
- The good results obtained were certainly due to the careful attention given to the structural rehabilitation procedure from the start. A valuable output has already been obtained: the development of a pilot technology providing excellent technical results, and the re-opening of the normal operation of the docks (Fig. 5).
